L73X-  
R.03.18

Official After Sales Network  
Wheel Drive Pegs Substitution  
18 December 2018  
5

Wheel Drive Pegs Substitution

Aventador SV

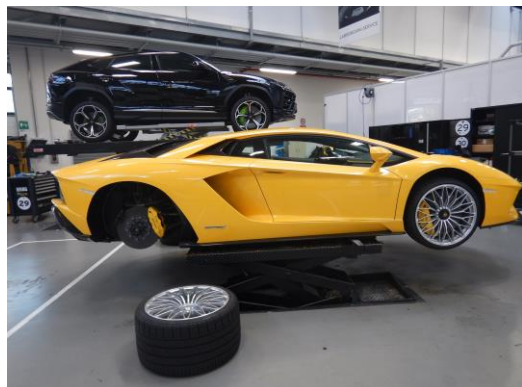
1. Raise the car on the lifter.

The car must be kept on the lifter for the whole duration of the operation, even during the tightening of the all four centre wheel nuts.

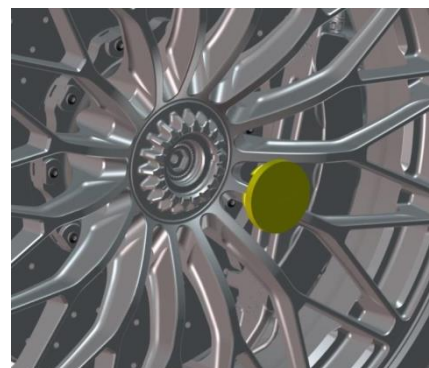
2. With the special tool 62553000271 carefully remove the hub cover by inserting the hook into the single nut's groove.

Take care not to damage the wheel rim.

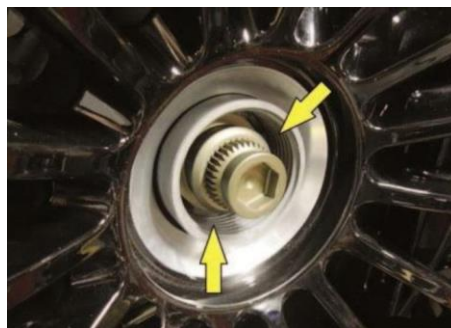
7. Lubricate the thread on the hub with CASTROL OPTIMOL PASTE TA.

Ensure that the other components are clean and free of grease.

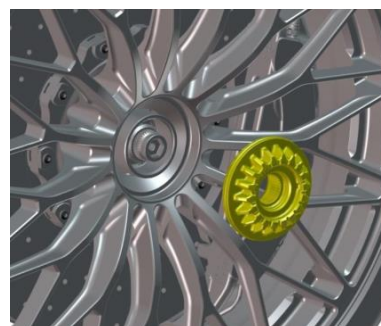
8. Reinstall the wheel and tighten the new Single Nuts, supplied as spare parts, with the special tool 470012257.

Tighten the nut to the specified torque: see Aventador SV shop manual:

**06 Wheels, Brakes/01 Wheel and tires/Single nut/Disassembly/Assembly.**

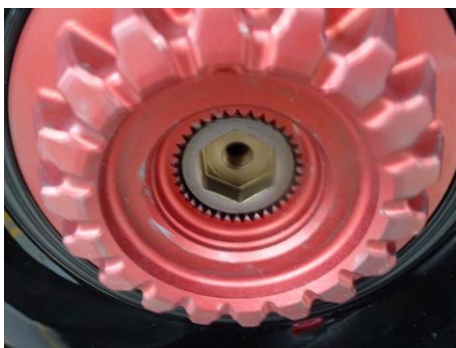
Pay attention to the safety block engagement: do not use the vehicle if the safety block is not correctly engaged in the single-nut.

**OK: Correct engagement**

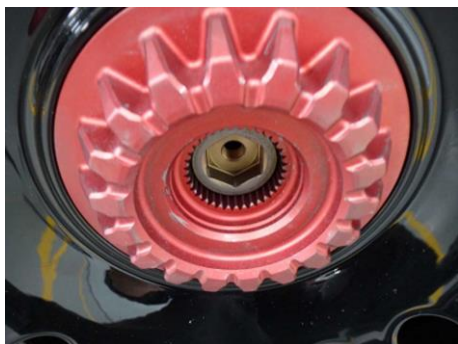
**NOT OK: Not engaged**
